Home Inspection Report

For
123 Anywhere Street USA

**Inspection Date:
May 31, 2020**

**R. Edwin Bass, Jr.
Bass Home Inspections LLC**

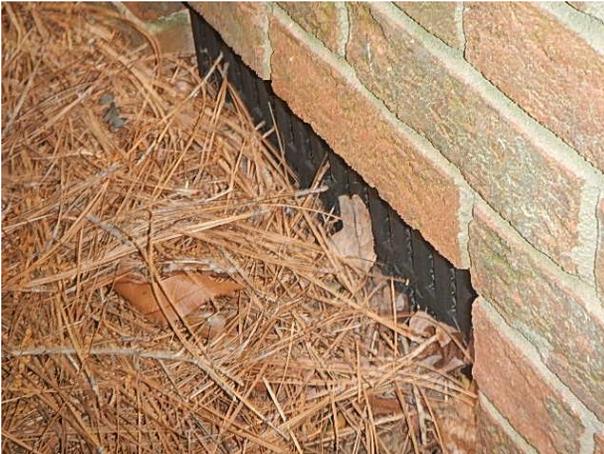
There were foundation vents that sat at ground level. This is a place for possible water entry into the crawl space during heavy rains. Foundation vents that sit less than 4" above the yard grade should have a vent well on them. Among foundation vent(s) noted were

the front side right foundation vent. Recommend having a qualified contractor install foundation vent well(s) to help divert the water away from the foundation vent(s).

Foundation vent sat at ground level

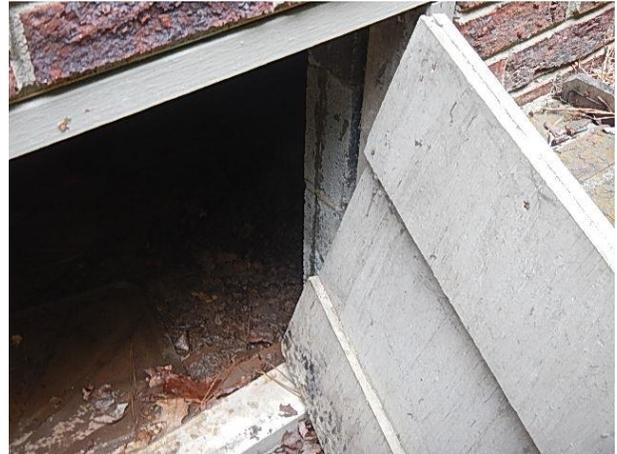
The left side crawl space door was loose at the bottom hinge and needs re-securing. This is a place for potential critter/insect entry. Recommend further evaluation and repair/replacement by a qualified contractor.

Loose lower hinge on crawl space door

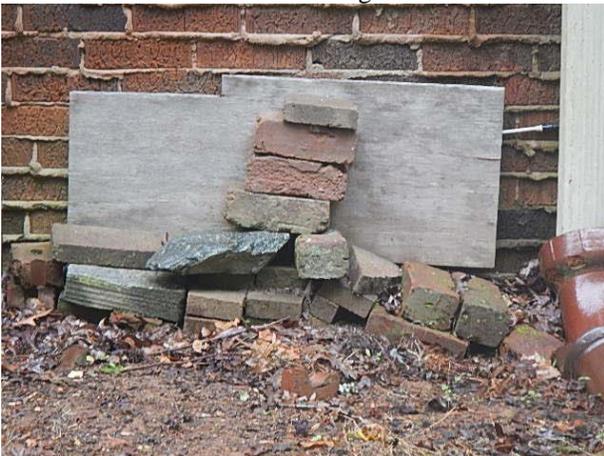
The rear side crawl space accesses was just plywood leaning against the house, and not hinged. This is a place for critter/moisture entry. Recommend further evaluation and repair/replacement by a qualified contractor.

Plywood leaning against rear wall openings

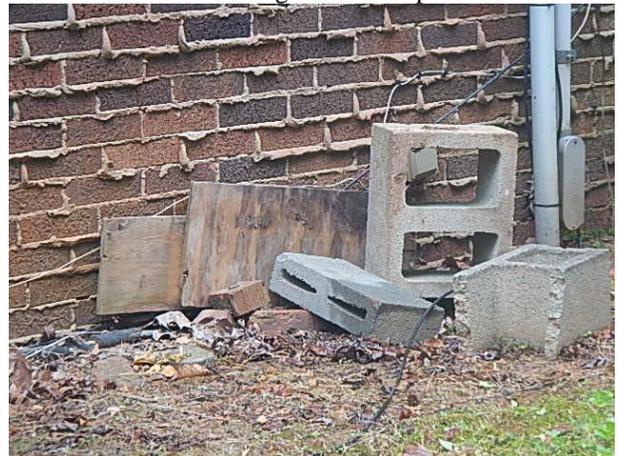
Plywood leaning against rear wall openings

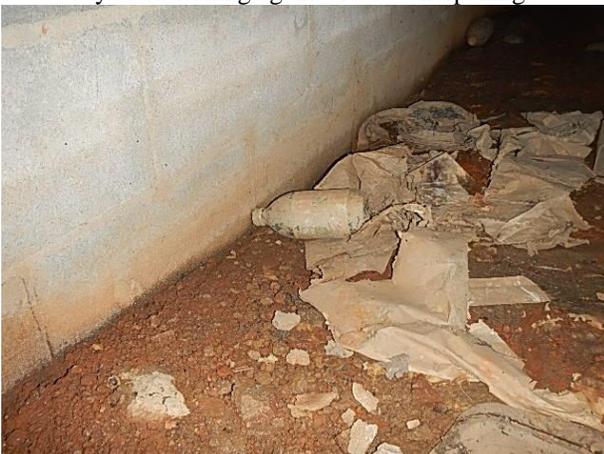
There was evidence of water entry in the crawl space. There was water staining on the piers, and foundation walls. The ground was also soft in places. Water in the crawlspace leads to unhealthy environmental conditions, such as fungal growth. Wet crawl spaces can also attract wood destroying insects. A perimeter French drain/sump pump system may be necessary. This is considered an expensive repair. Further evaluation and repair by a qualified water proofing/foundation repair contractor. This should be done before closing on the property.

Water staining on foundation walls

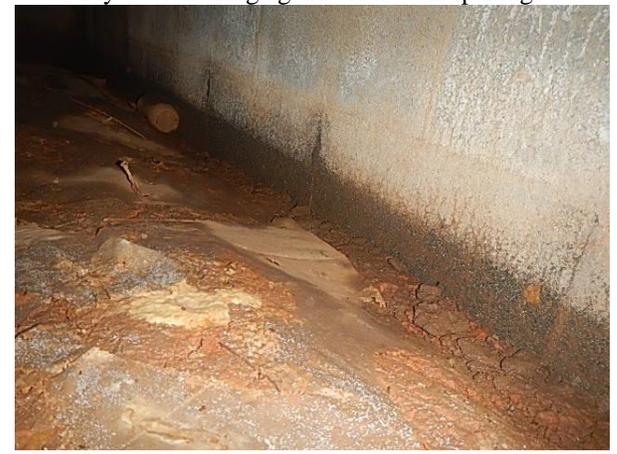
Water staining on foundation walls

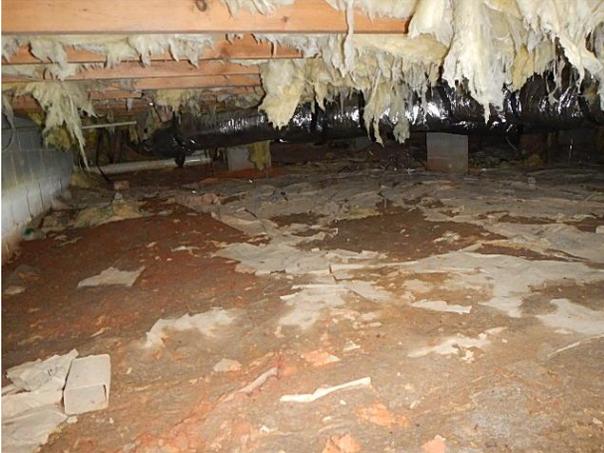
The crawl space vapor barrier was brittle, damaged, and old and needs replacement. A vapor barrier is the plastic on the crawl space ground that controls the moisture evaporated from the ground. Without proper ground coverage, unhealthy environmental conditions (such as fungal growth on floor joists) can occur. Recommend replacement of the vapor barrier by a qualified contractor.

Damaged vapor barrier

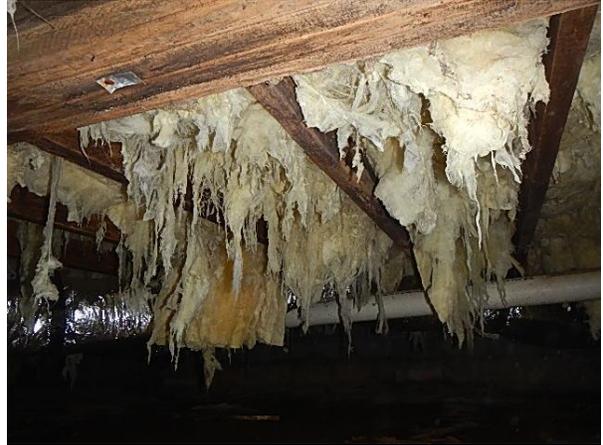
The crawl space insulation was stringy, loose, and fallen in places. This was caused from high humidity/moisture levels in the crawlspace. Stringy insulation usually needs replacement. There was also some missing insulation observed as well. Recommend further evaluation, and repair/replacement as needed, by a qualified insulation contractor.

Stringy, fallen insulation

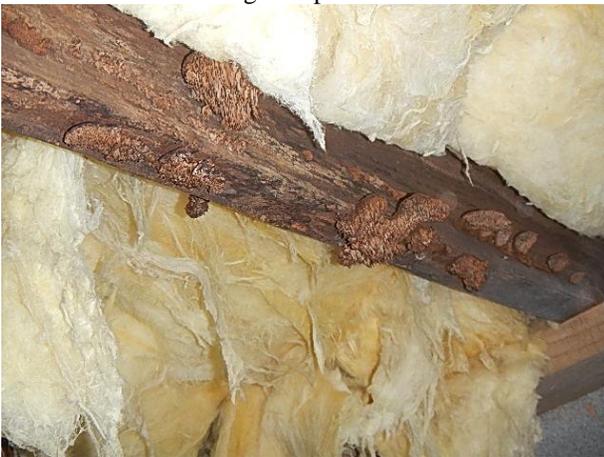
The floor joists in the crawlspace had areas covered with a substance resembling fungal growth/mold. This condition indicates moisture intrusion in the crawlspace. Mold can only be positively identified through sampling and analysis by qualified personnel. Expanding mold colonies can cause mold spore concentrations in indoor air to rise to unhealthy levels. Conditions that encourage mold growth can also cause structural damage from wood decay. The moisture meter showed elevated levels of moisture present in floor joists at the time of the inspection (20% or higher). There were several floor joists observed at the front side area that had some wood decay on them. Recommend further evaluation and repair by a qualified contractor.

Fungal growth on floor joists

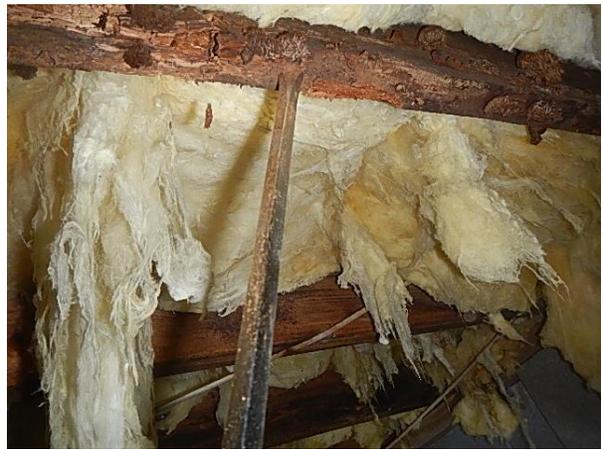
Wood decay at several floor joists

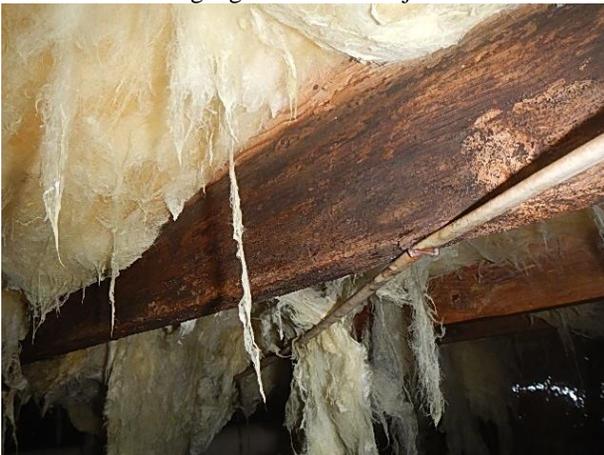
Fungal growth on floor joists

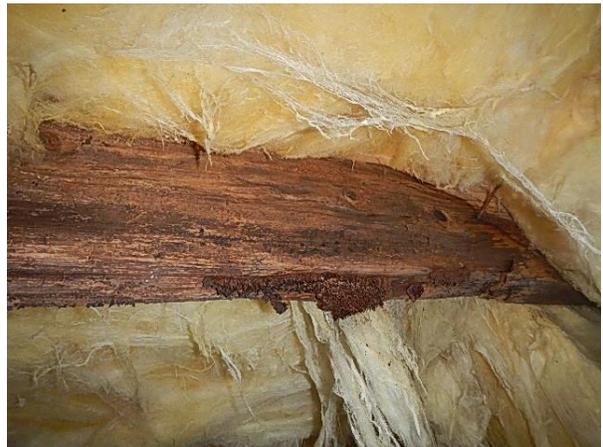
Fungal growth on floor joists

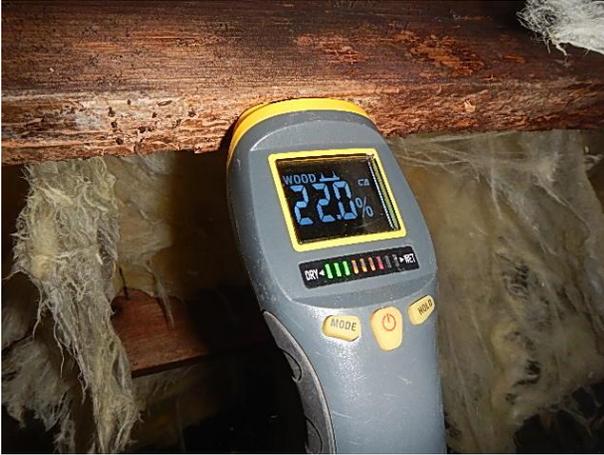
Moisture content in flor joists high

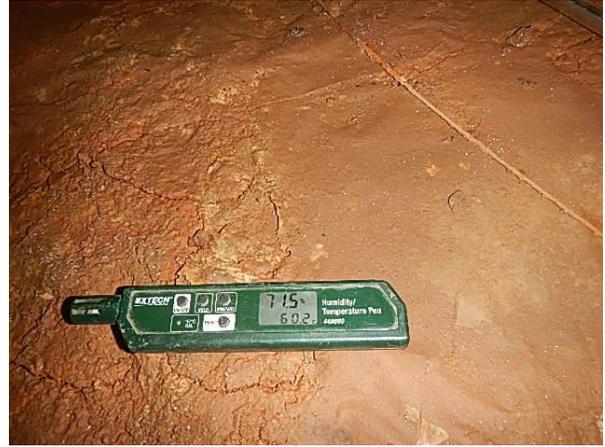
The relative humidity in the crawl space was high at the time of inspection- 70%. Relative humidity over 60% in the crawl space leads to unhealthy conditions, such as fungal/mold growth. The installation of a crawl space dehumidifier that drains to the outside and sealing off the foundation vents would probably solve this issue. This can be a costly repair if the proper type of crawl space dehumidifier is used. Recommend further evaluation and repair as needed by a qualified water proofing contractor/foundation repair contractor.

High relative humidity in the crawl space

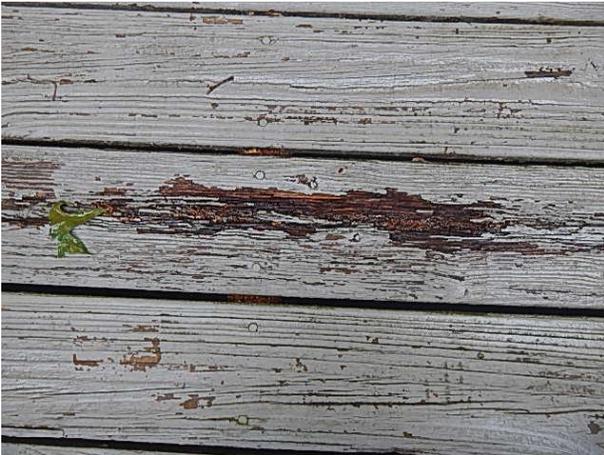
The decking boards showed signs of wear and are at or near the end of their design life. There was cracking noted in the boards, as well as damaged decking boards. The average design life for wooden decking boards is 15-20 years, assuming proper maintenance. Recommend further evaluation as to life expectancy, and repair as needed, by a qualified contractor with deck repair experience.

Damaged decking boards

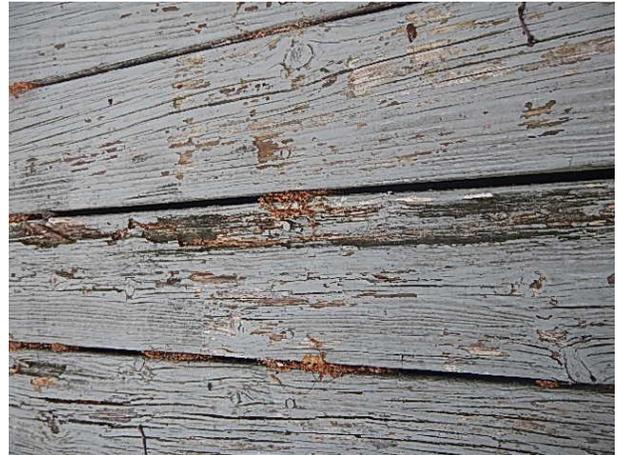
Damaged decking boards

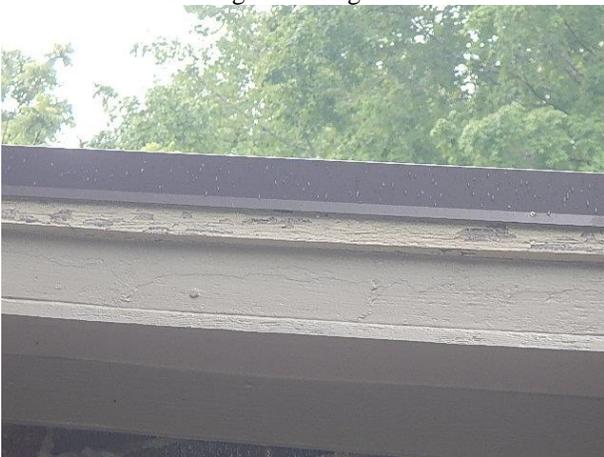
The following exterior area(s) will need painting: the right side rake board. There was exposed wood that needs protecting. Recommend further evaluation and repair by a qualified painting contractor.

Right side rake board needed painting

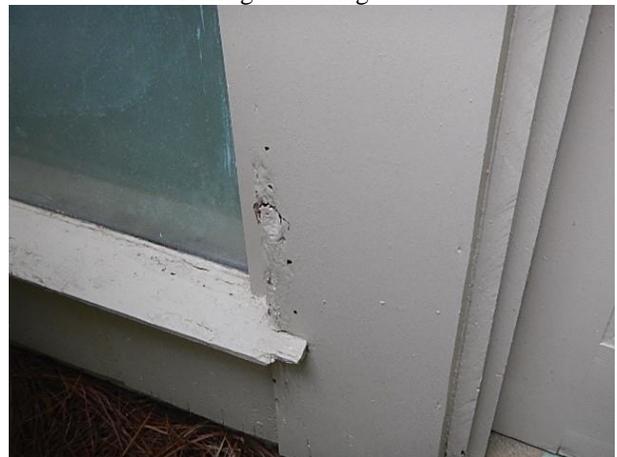
There was damaged/decayed wood siding noted on the house at the following location(s): one piece to the left of the front right doors. This can allow water entry which can lead to damage to the wall sheathing components. Recommend further evaluation and repair by a qualified contractor.

Soft wood to the left of the front right doors

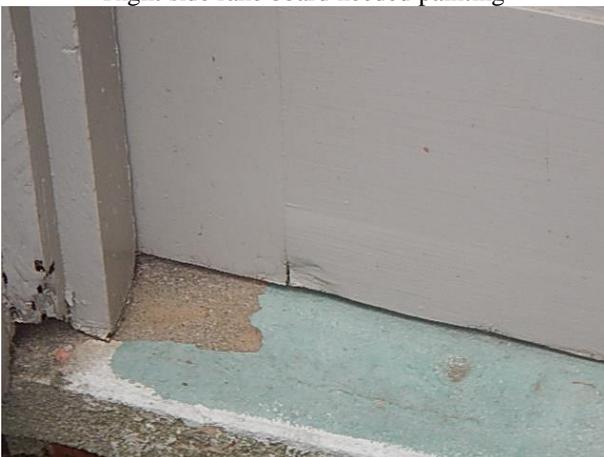
The exterior front right doors had soft and decayed wood at the bottom of the doors. Recommend having a qualified contractor repair/replace the doors.

Soft wood at front right doors

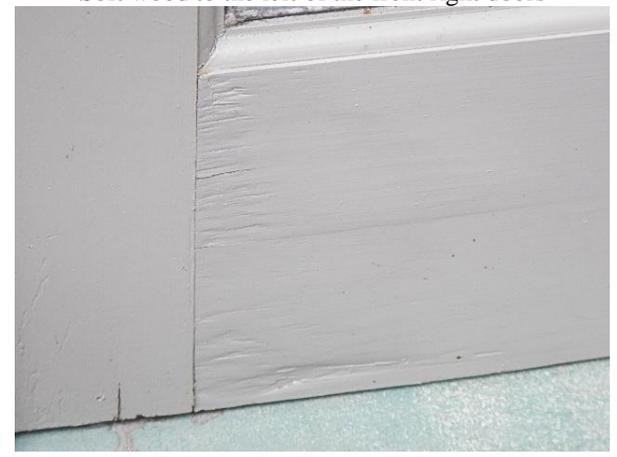
Soft wood at front right doors

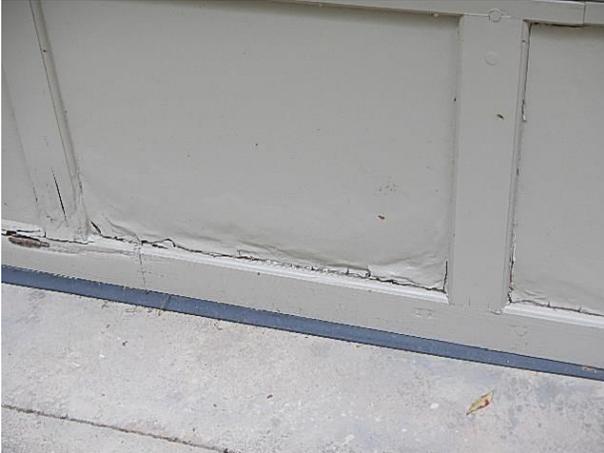
The rear garage door had damaged bottom panels and a lower rail on it. Recommend further evaluation and repair/replacement by a qualified garage door contractor.

Damaged garage door panels

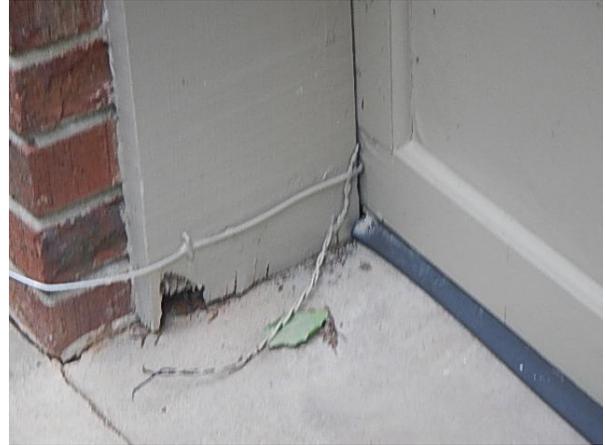
There was damaged bottom wood trim noted at the side of rear garage door. Recommend having a qualified contractor repair/replace.

Damaged wood trim beside garage door

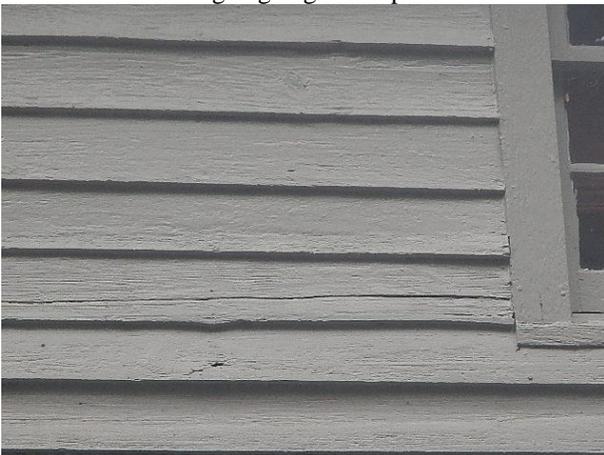
There was cracked wood siding noted on the house at the following location(s): a couple pieces at the rear side upper area. This can allow water entry which can lead to damage to the wall sheathing components. Recommend further evaluation and repair/replacement by a qualified painting contractor.

Cracks in wood siding need sealing

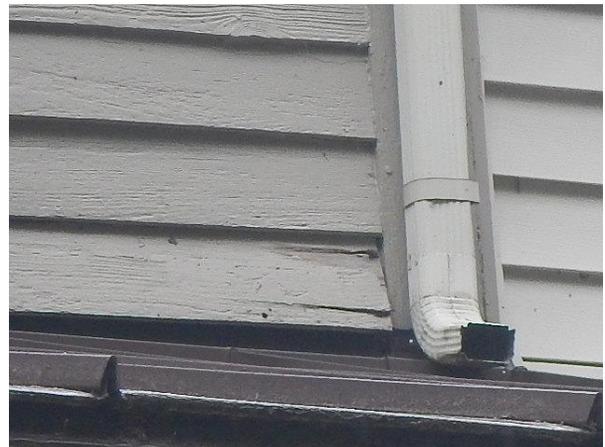
Cracks in wood siding need sealing

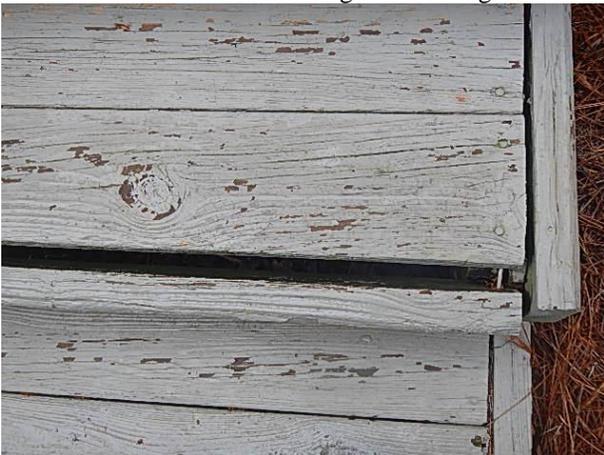
There were loose lower wooden step risers on the rear side steps. This is considered a safety/tripping issue. Recommend having a qualified contractor repair/replace the step(s).

Loose deck step riser

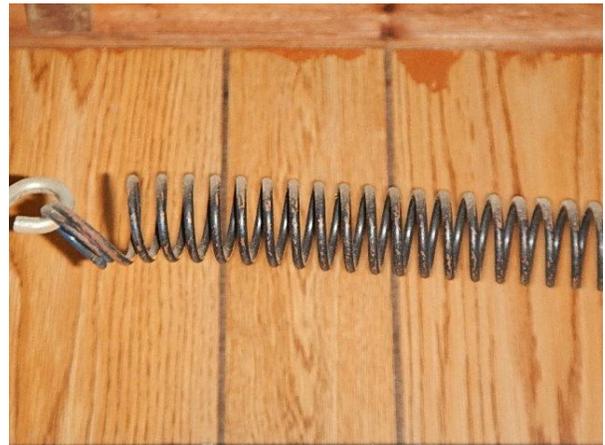
The garage door extension springs should have a containment/safety cable running through the springs. This is considered a safety issue should the springs ever break. Recommend having a qualified contractor install.

Garage door springs need safety cable in them

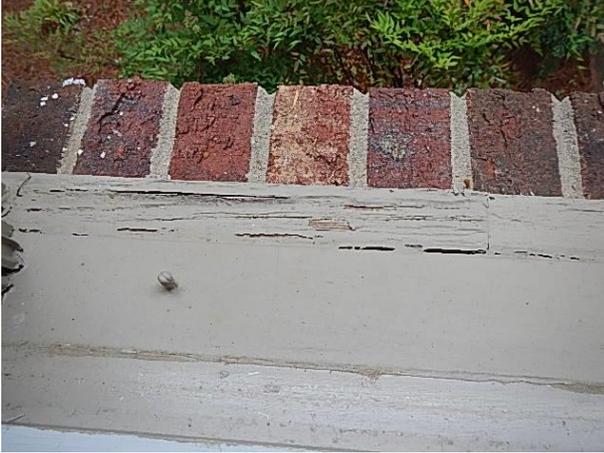
Several of the upstairs window stools will need attention. There was cracking observed in them- a place for water entry. Recommend having a qualified painting contractor repair.

Window stools will need attention

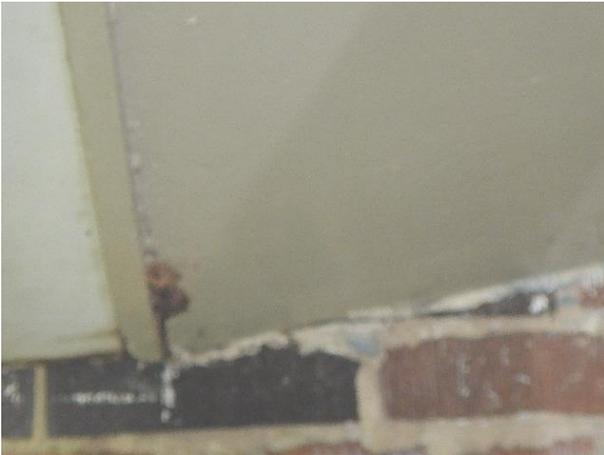
There was damaged/decayed wood soffit board (a hole) located at the left side of the sunroom and above the rear garage door (cracked) that needs repairing/ replacement. This is a place for possible critter/insect/water entry. Recommend further evaluation and repair by a qualified contractor.

Damaged soffit

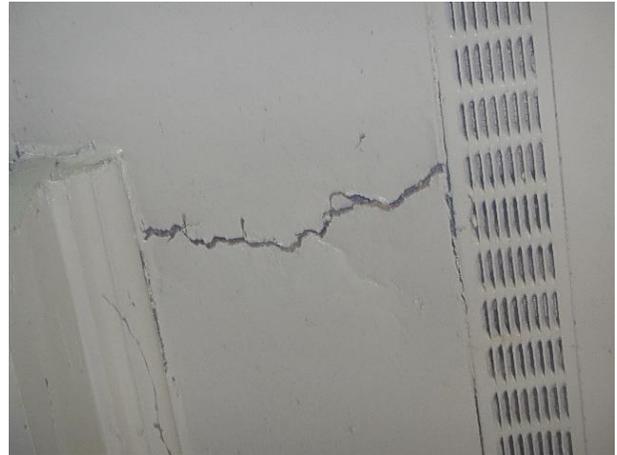
Cracked soffit

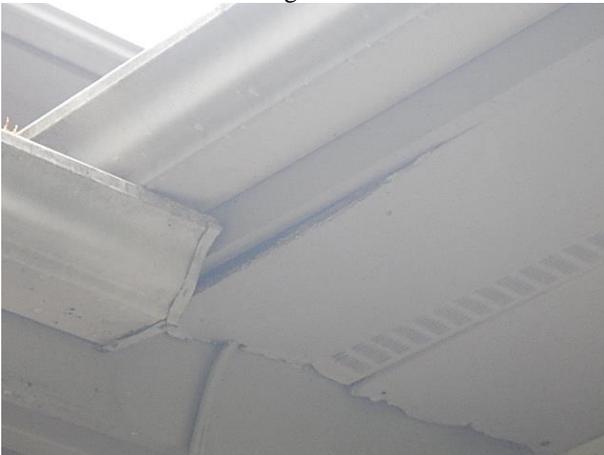
There were cracks/gaps noted at the wood soffit/fascia at the rear side at the house/garage corner. This is a place for possible insect entry. Recommend having a qualified contractor repair.

Gap in the soffit

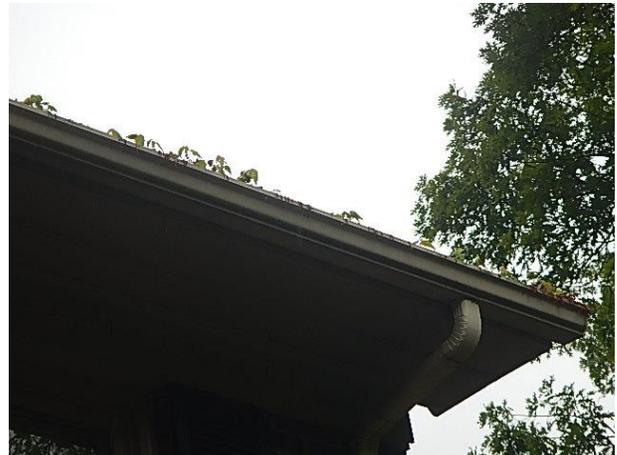
The gutters were full of leaves/debris and need cleaning out for them to function properly. Full gutters can allow the water to damage the fascia/soffit; and it can also lead to high moisture levels in the soil which can affect the ability of the soil to support the foundation.

Plants growing out of the front gutter

Full gutters can also lead to water entry in the crawl space. Recommend having a qualified contractor clean them out as well as checking the downspout connections.

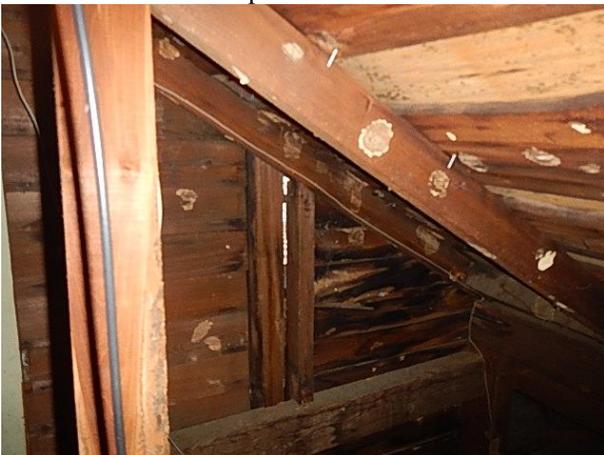
There was daylight seen in the walk-in attic at the following location(s): several places at the left and front sides. This is a place for possible water/insect entry. Recommend further evaluation and repair by a qualified contractor.

Daylight seen in walk in attic

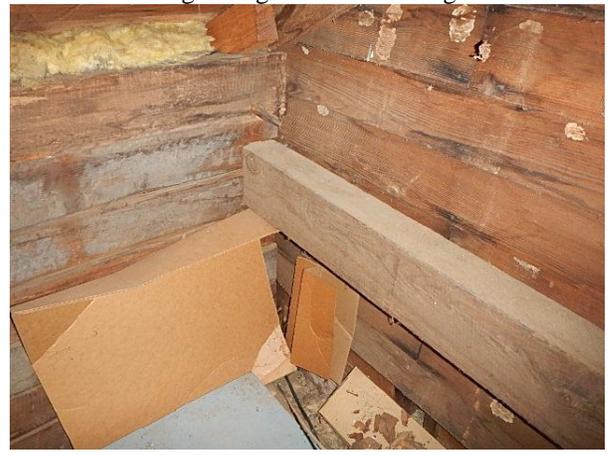
Daylight seen in walk in attic

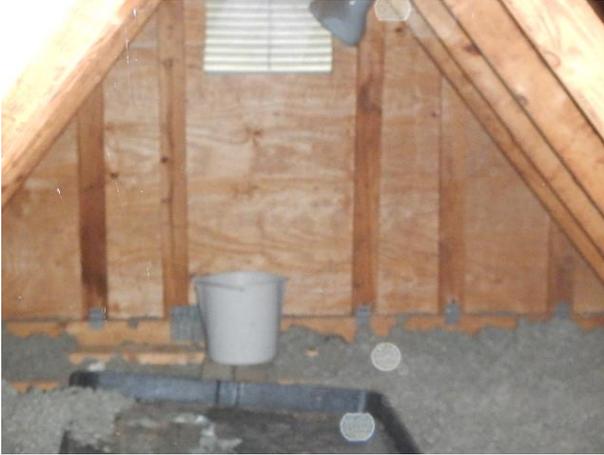
There was a five gallon bucket in the main attic at the right side under the gable vent. This is usually done for roof leaks. Recommend further evaluation and repair as needed by a qualified contractor.

Bucket in the attic

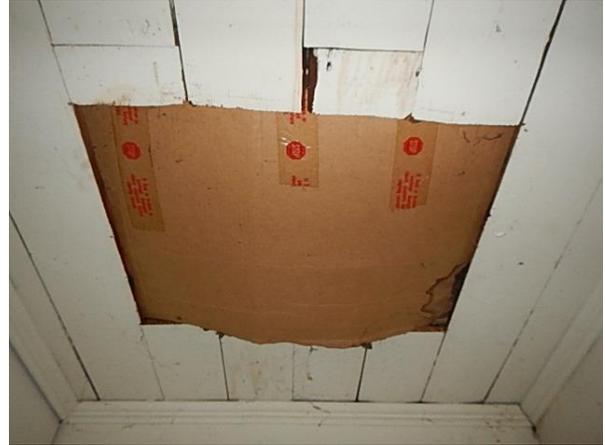
There was a piece of cardboard at the ceiling scuttle in the second floor front right bedroom closet. This is a place for interior air to escape. Recommend replacing the cardboard with a piece of plywood

Recommend replacing the cardboard with plywood

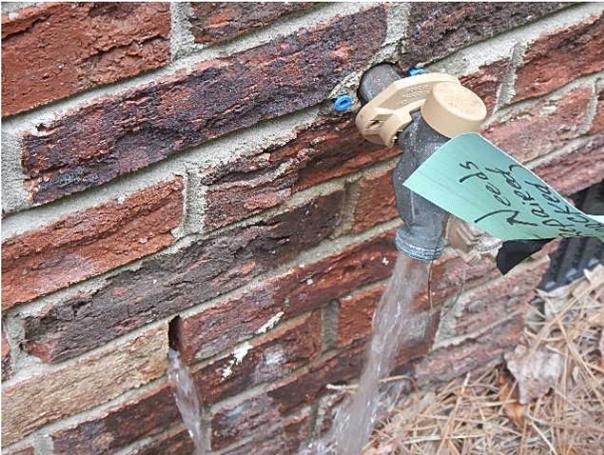
There was a leak observed at the back side of the exterior left side hose bib (faucet). The water piping in the foundation wall was cracked. Recommend further evaluation and repair/replacement as needed by a licensed plumbing contractor.

Crack in faucet water piping

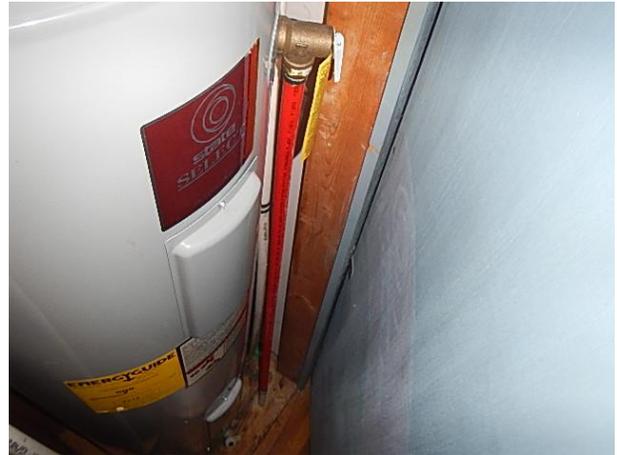
The discharge pipe of the water heater temperature/pressure relief (TPR) valve discharged into the crawlspace. This condition is no longer allowed and is considered improper. The discharge pipe termination must be visible in case it were to ever open and release its water. Recommend repair/replacement by a licensed plumbing contractor.

TPR discharge pipe discharges into the crawl space

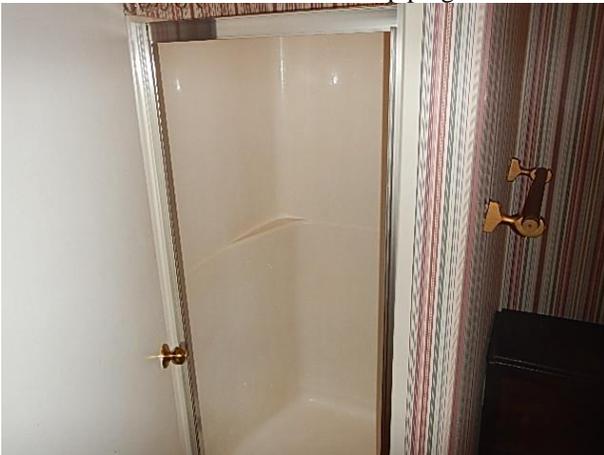
The first floor bathroom shower is missing its door. Recommend further evaluation and repair/replacement by a qualified plumbing contractor.

Missing shower door

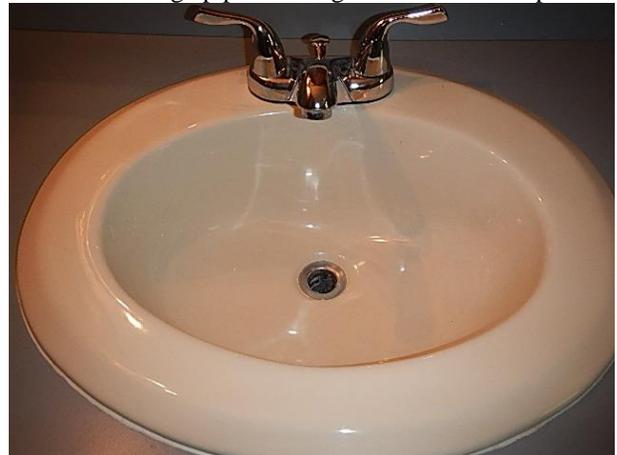
The second floor right side bathroom sink stoppers were missing/not installed- the sinks did not hold water. Recommend having a qualified plumbing contractor replace the sink stoppers.

Missing sink stopper

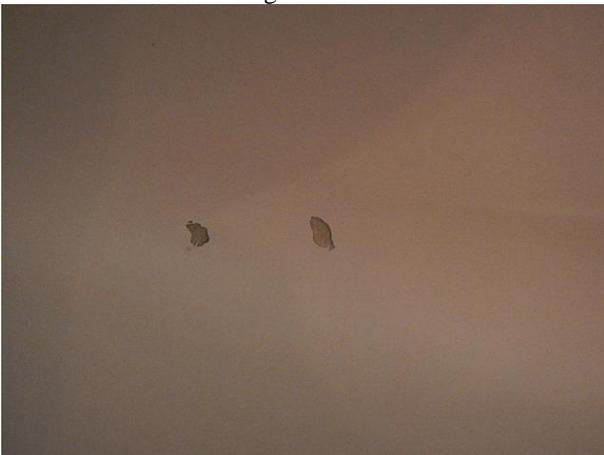
There was a crack/chip noted in the second floor right side bathroom tub fiberglass finish. This is a place for a possible water leak. Recommend further evaluation and repair/replacement by a qualified contractor.

Chips in tub finish

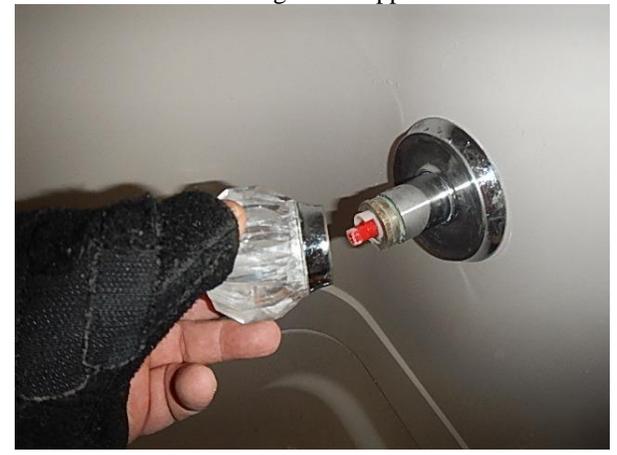
The second floor right side bathroom tub handles will need adjustment. The handles spin around and do not properly control the tub water flow. The hot water handle was also loose. Recommend having a licensed plumbing contractor repair.

Loose tub hot water handle

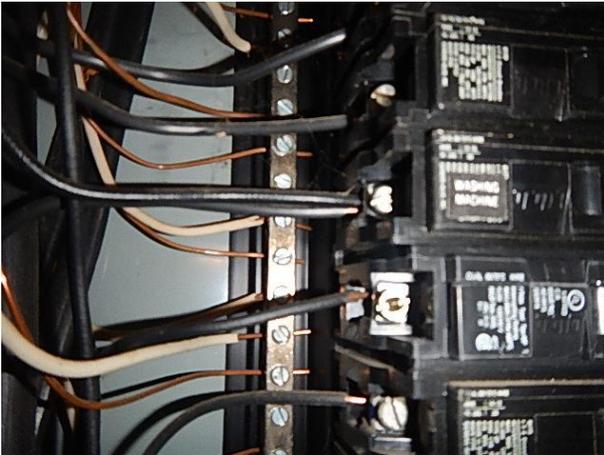
Double tap at breaker

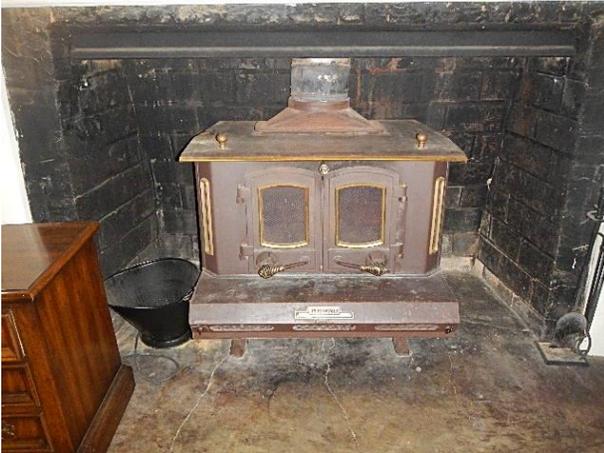
Wood burning stove in fireplace

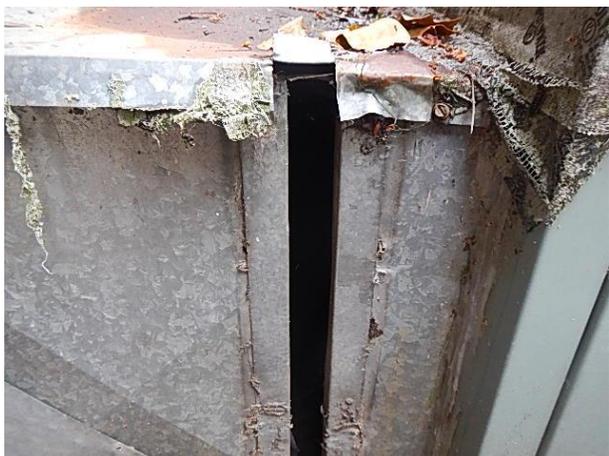
Missing air filter at the package unit

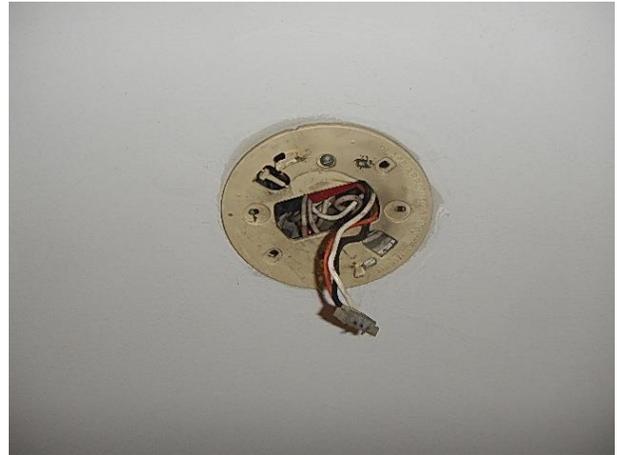
There was a missing smoke detector noted on the second floor. This is considered a safety issue. Recommend repair/replacement by a qualified contractor.

Missing smoke detector

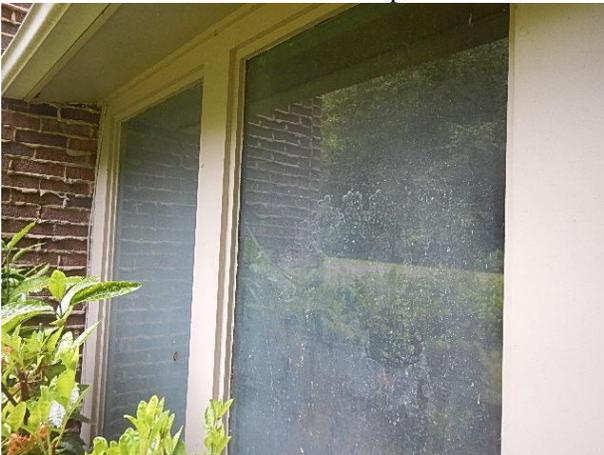
Broken seal on windows

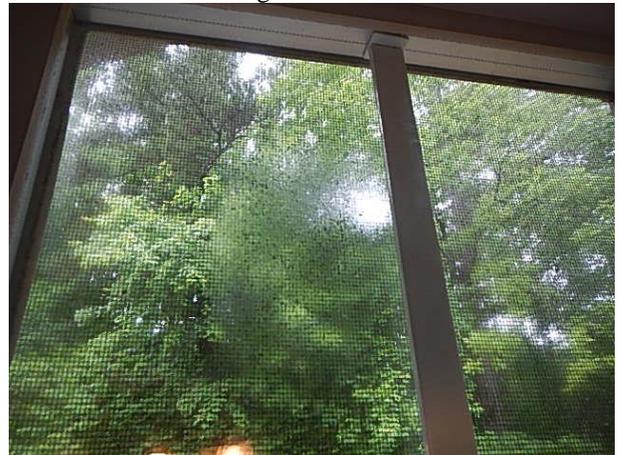
Broken seal on windows

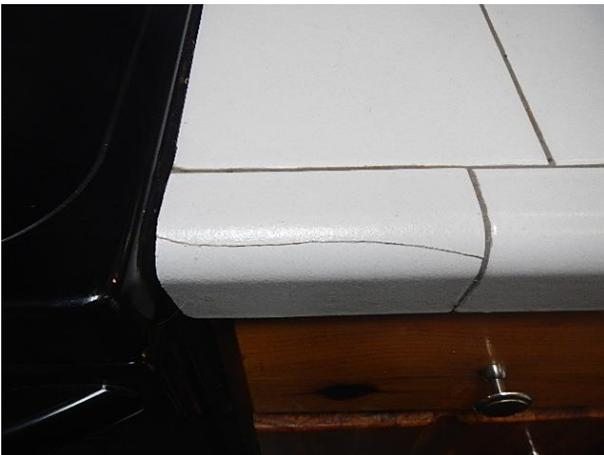
Cracked ceramic tile on kitchen countertop

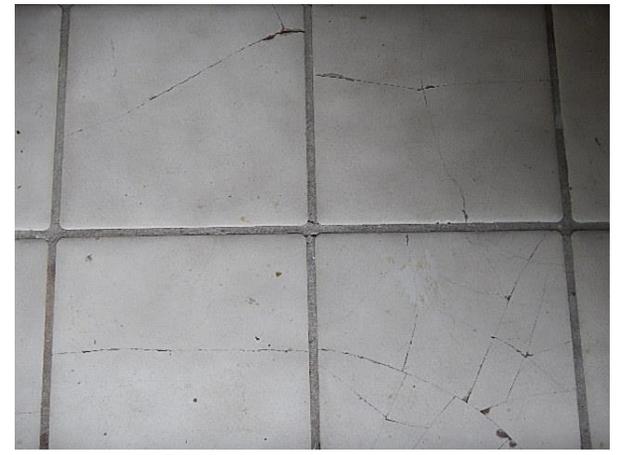
Cracked ceramic tile in foyer

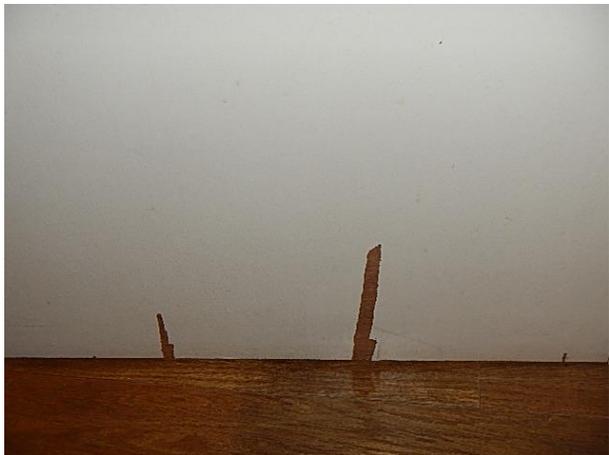
Damaged interior door

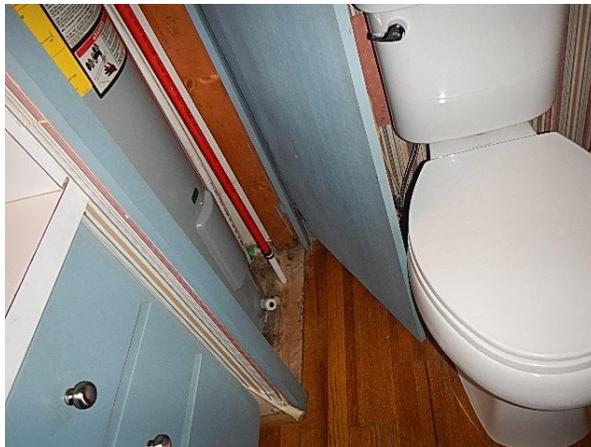
Closet door hits the toilet

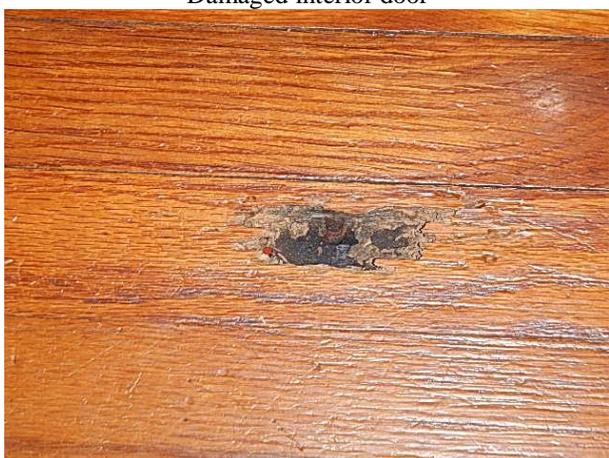
Damaged hardwood flooring

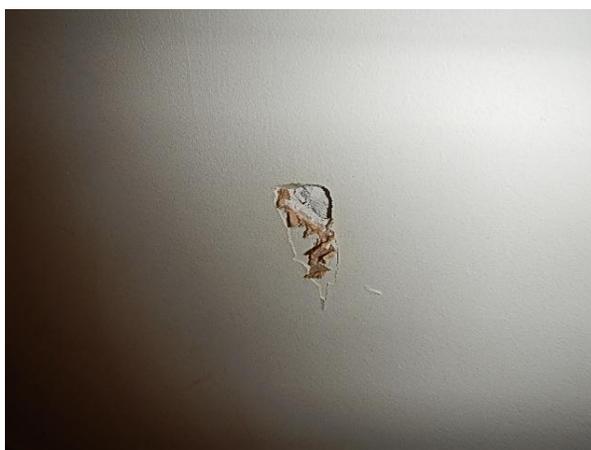
Damaged wall

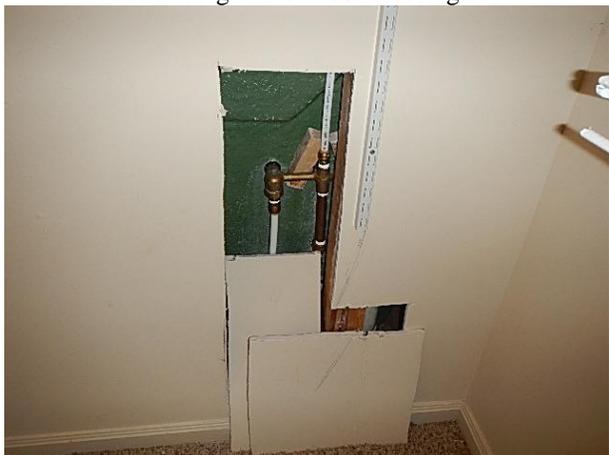
Hole in the closet wall

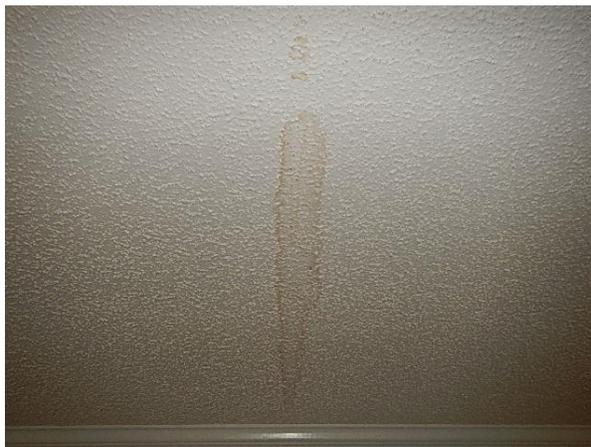
Water stain on bedroom ceiling
